## M4 Junction 28 Improvement Works, Newport, South Wales

### Road Safety Audit Stage 1

**TMS reference no: 12370A**

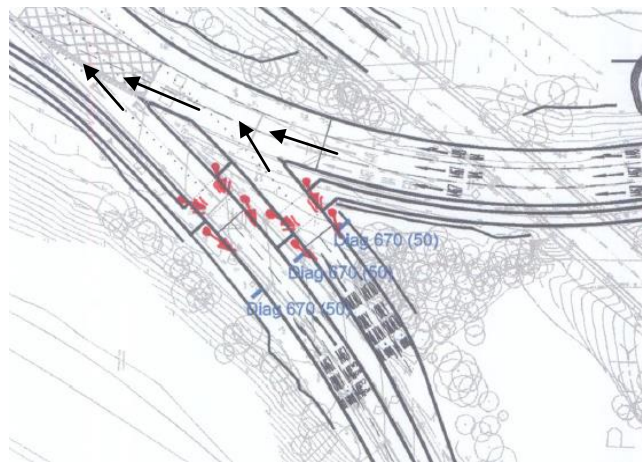
Location – M4 westbound diverge slip road and circulatory carriageway

The M4 eastbound exit slip on the north east approach to the circulatory carriageway is shown to have traffic signals but it is not clear if these are purely for the controlled pedestrian crossings or the signals are integrated into the circulatory carriageway phasing and staging.

*In addition, although the drawing shows an adjacent stop line on the circulatory carriageway, no traffic signals are shown. This should be added at detailed design stage.*

It should be clarified at detailed design stage if the approach is to be integrated into the junction signalisation.

*Give way markings to cater for the eventuality of the signals failing.*

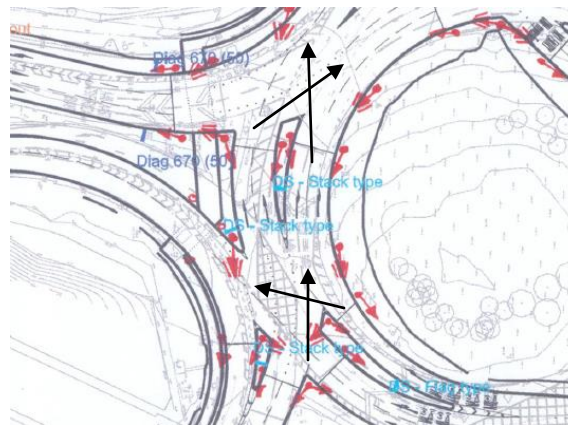
Location – Circulatory carriageway; northern quadrant

Within the northern quadrant of the circulatory carriageway, there is a potential for drivers to get into the incorrect lane in advance of the splitter islands on approach to the traffic signals. In the event that drivers do get into the wrong lane, they may attempt to correct themselves after passing the stop line, which may result in side-swipe vehicle collisions following crossing or converging manoeuvres (as indicated in the graphic below).

Appropriate traffic routes should be clarified by road markings and the alignment of splitter islands.
