Infrastructure Report University Hospital Wales & University Hospital Llandough

July 2021

Cardiff and Vale University Health Board Infrastructure Report

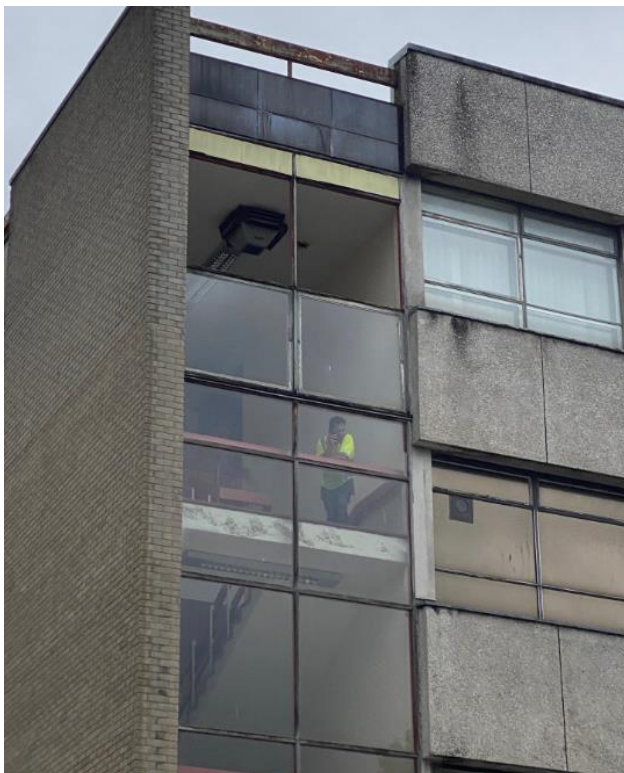
Within the UHW Site, the majority of the Main Tower and Link Blocks are constructed with traditional and original steel frames with single glazed panels. Due to the age of these units and they're life expectancy, we regularly find throughout the winter months, a significant proportion of these windows present us with draft issues, reducing temperatures within the main Ward Areas. The buildings loose a significant amount of heat due to its thermal inefficiency, resulting in higher overall running costs to the hospital and an unpleasant patient experience.

Due to the height of the windows, access to fix/replace a number of the windows is not safe, and therefore not appropriate, thus reducing the amount of repair works that can be undertaken at any time.

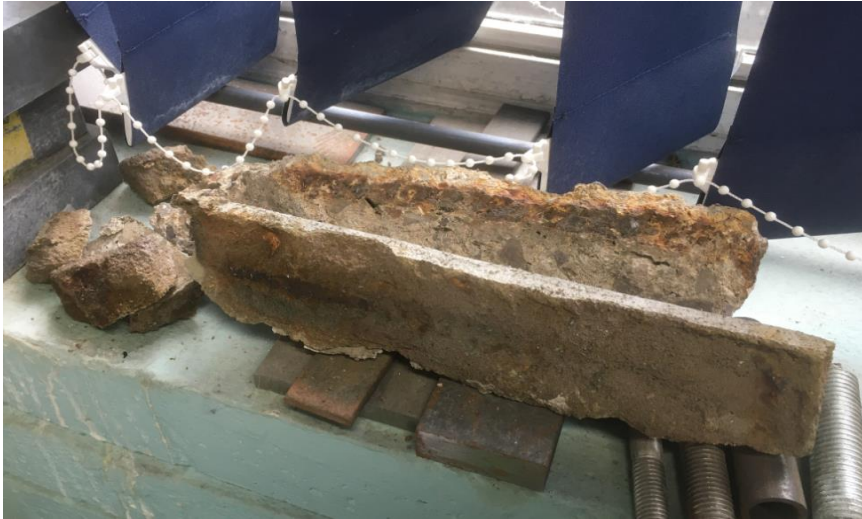
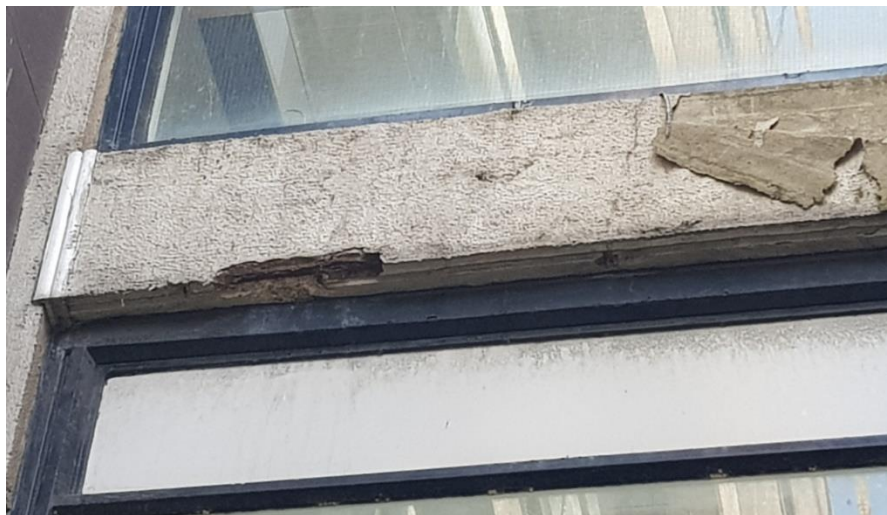
Within the UHW Site, the majority of the Main Tower and Link Blocks are constructed of cast concrete with a cement rendered finish. The life expectancy of concrete, weather conditions and lack of maintenance due to access, have contributed to the deterioration of sections, resulting in the concrete façade starting to break away from the main structure of the tower and falling from a height to the ground. This poses a potential life threatening danger to patients, staff and visitors.

To future proof the buildings, the concrete façade needs to be removed from the buildings and replaced. This will significantly impact the use of these buildings with potential significant disruption to the delivery of Clinical Services and patient experience. There may be instances where elements of the buildings will need to be closed to facilitate these works

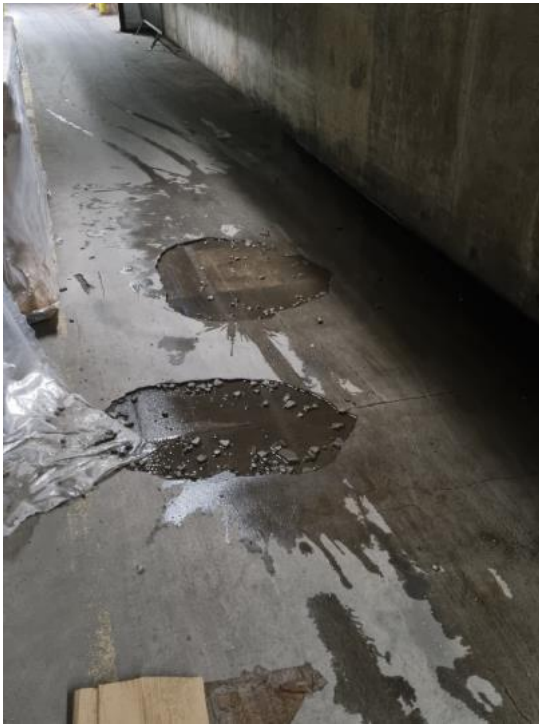
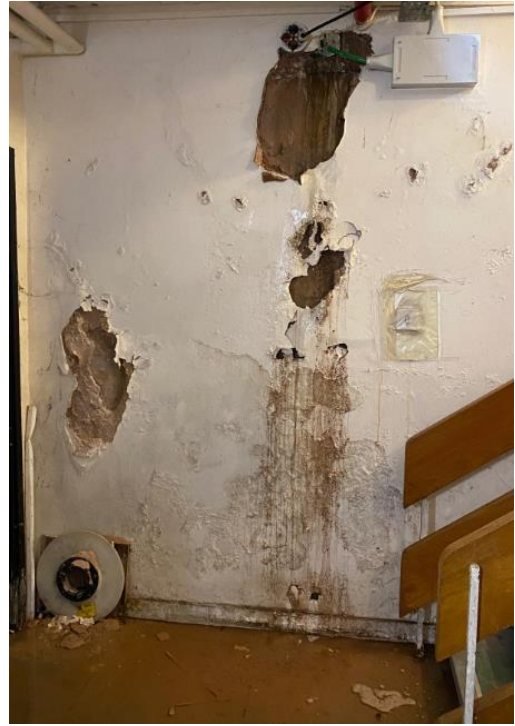
There are ongoing issues with ground water ingress into the tunnels under UHW, primarily due to the age of the tunnels, the high volume of traffic (tugs, patient movement etc.) 24/7 use to keep hospital logistics running smoothly, have all contributed to their expected deterioration over time.

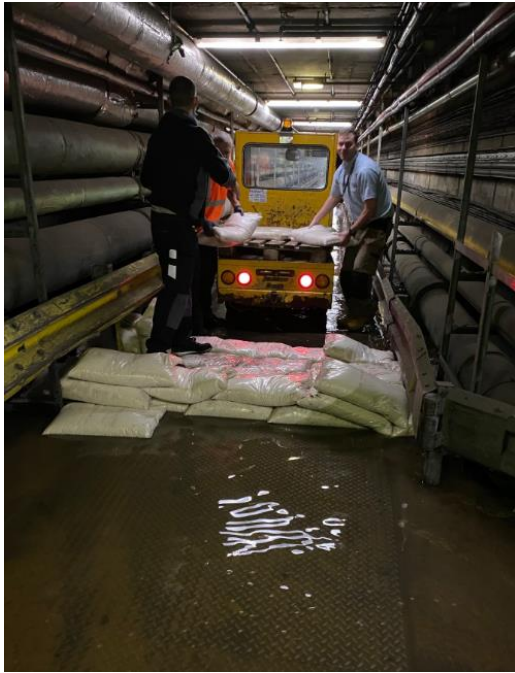
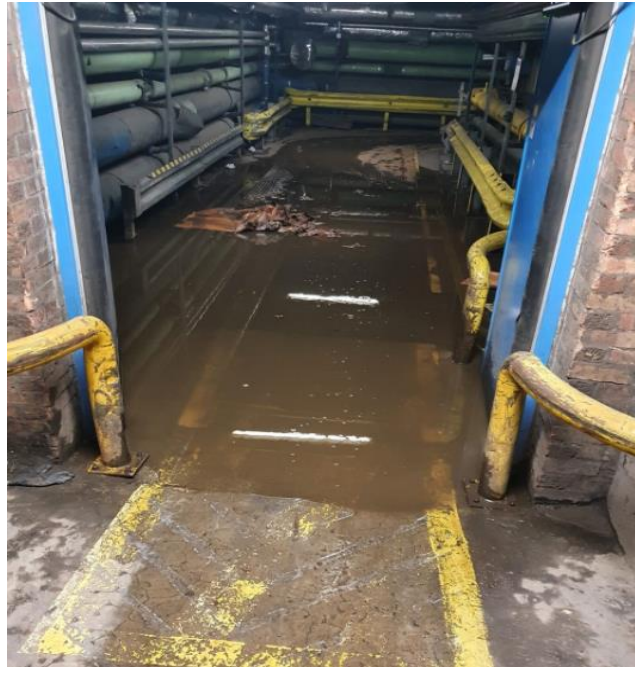
The tunnels are made of cast concrete sections that are showing clear evidence of breaking down, this is accelerated by the added increase and change of water table. The water table will continue to rise due to ongoing construction within the hospital grounds to meet the increasing demand for a greater footprint/ treatment space.

Increases to the water table cause frequent flooding issues in the tunnels, preventing access and impeding the daily logistical flow of the hospital.

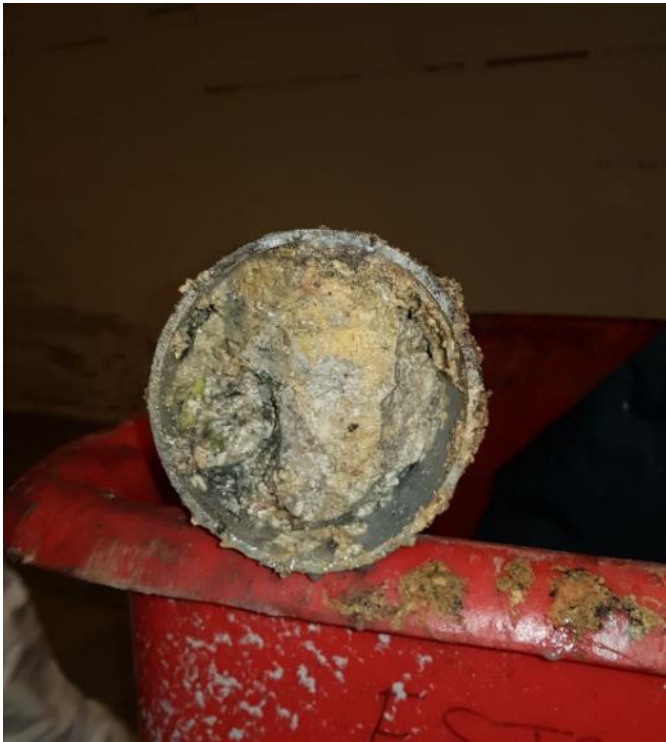
There are regular mechanical breakdowns brought on by general deterioration and corrosion of the waste pipes, resulting in a significant reduction in the internal diameter of the pipe. The reduced diameter in conjunction with inappropriate items being disposed of into the drainage/ toilet system results in frequent blockages. See photo below

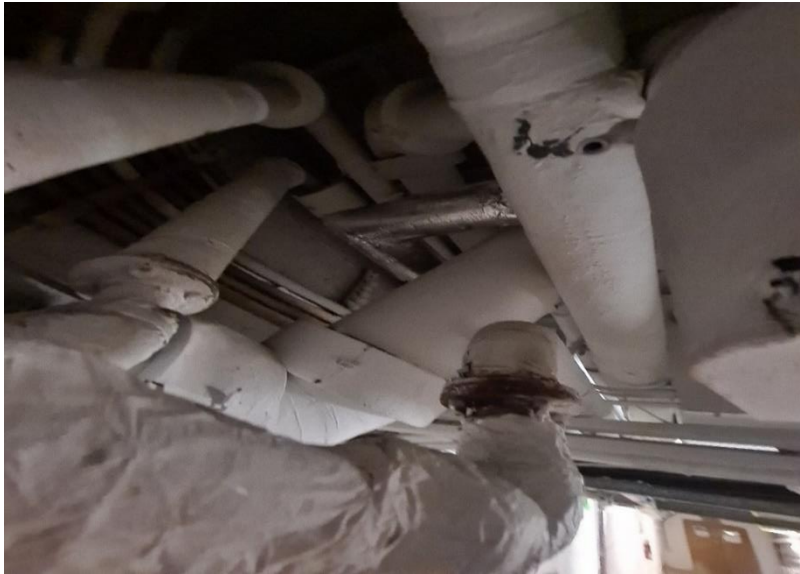
The UHL tunnels have pipework that is over 50 years old. The pipework and tunnels themselves have asbestos contamination, which has been encased (see photo below) by the white encapsulation paint. The asbestos and congestion within the tunnels makes any repairs extremely difficult, a simple repair can now take days to complete, and would in some cases stop services.

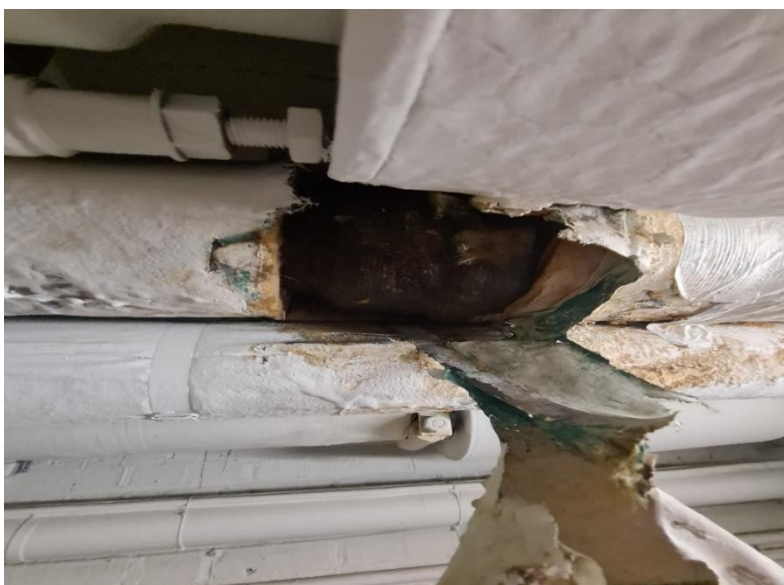
The photo below shows a failure on the condense steam pipe work. At the time it was necessary to shut down the theatre surgical sterilisation unit and Public Health decontamination units (TSSU) services at UHL for a weekend.

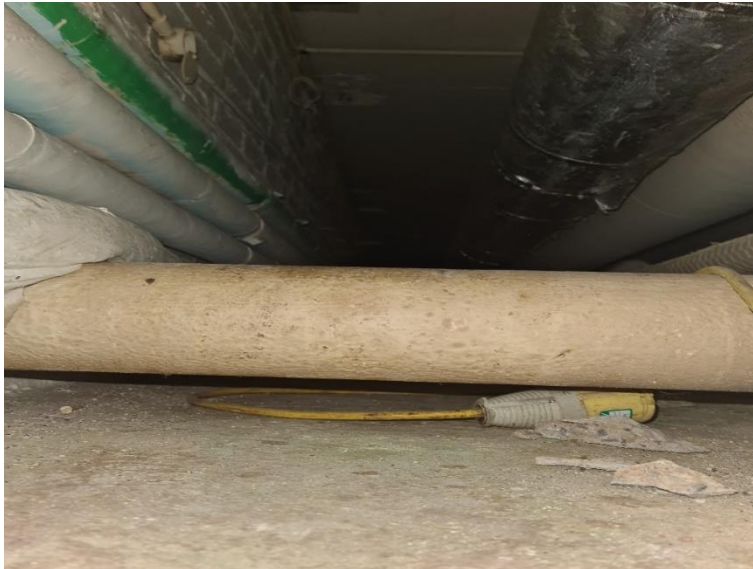
Below is an example of the crawl spaces where services run. These areas are out of bounds to staff as they are confined spaces and contaminated with asbestos. When failures occur in these crawl spaces, it takes a minimum of 48 hours to plan and employ a specialist contractor to repair the failures. Failures result in the loss of hot and cold water services to patients.

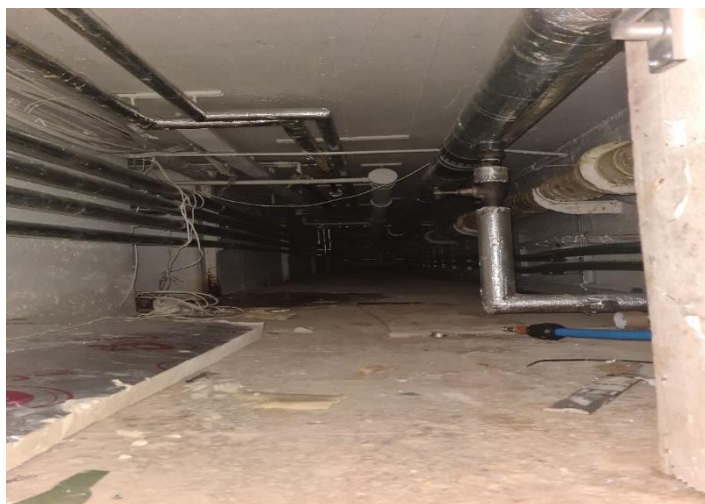
The photo below is a crawl space, 3ft high and 2ft wide, previously there have been blockages in the drainage system in this area. These blockages take in excess of a week to resolve due to the size and conditions of the crawl space. Our staff are unable to work in these spaces and specialist contractors are brought in when needed to complete works.

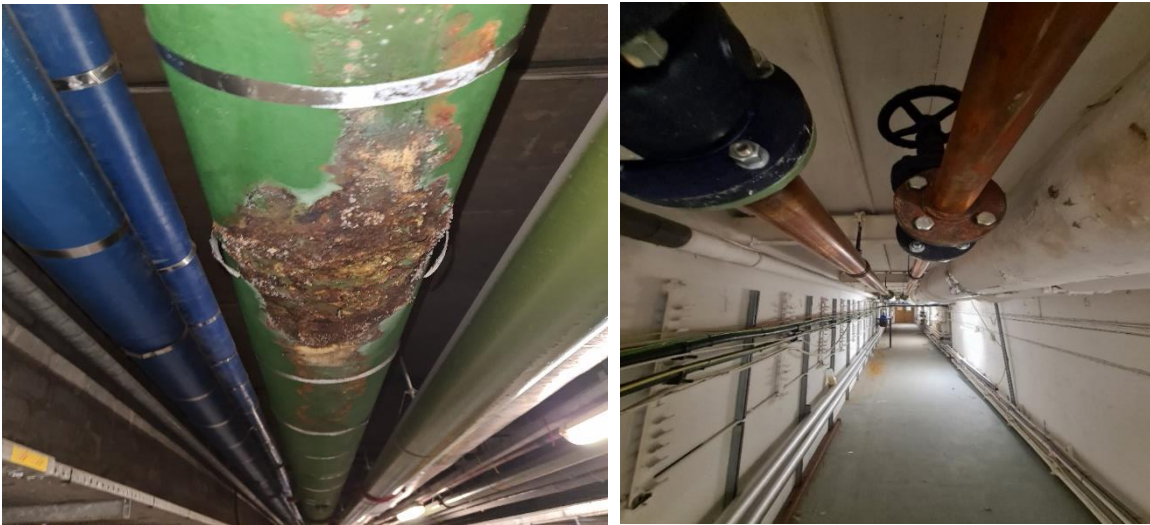
Photos below illustrates failures within the hot water system which resulted in patients losing the ability to wash while the repairs were carried out. The repair was made easier due to asbestos removal previously and the removal of redundant pipework.

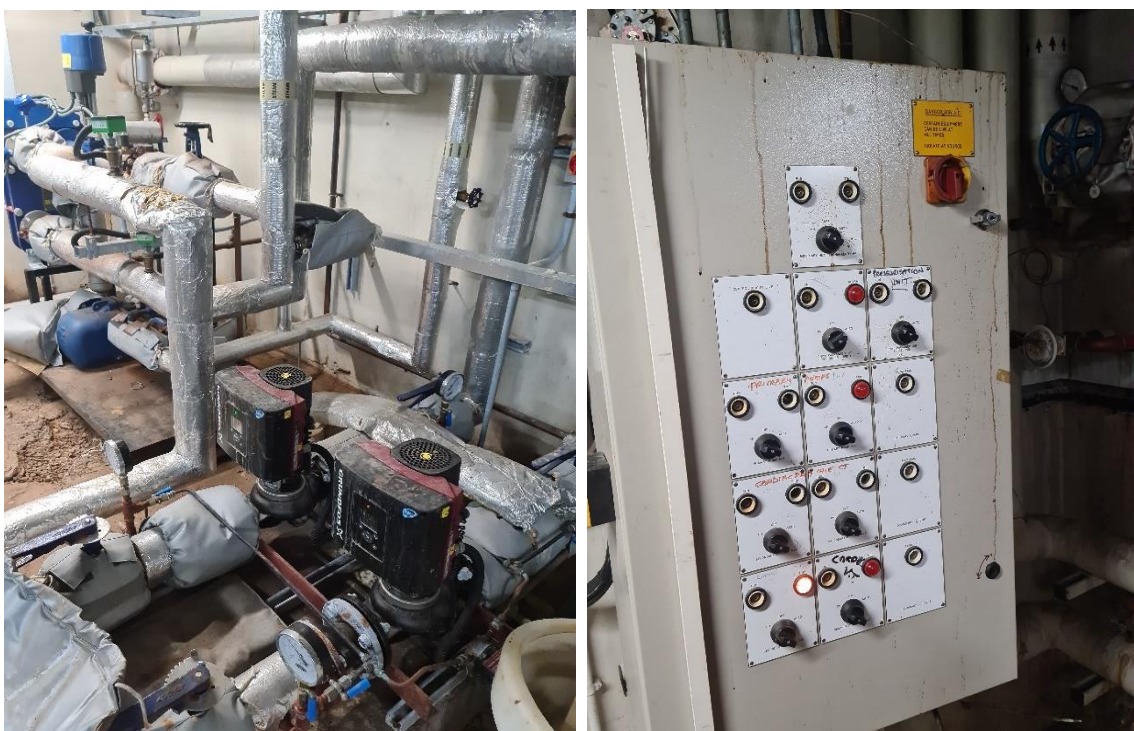
The pictures below show where we have failures within the plant rooms and you can see the ongoing repairs, as well as outdated control panels.

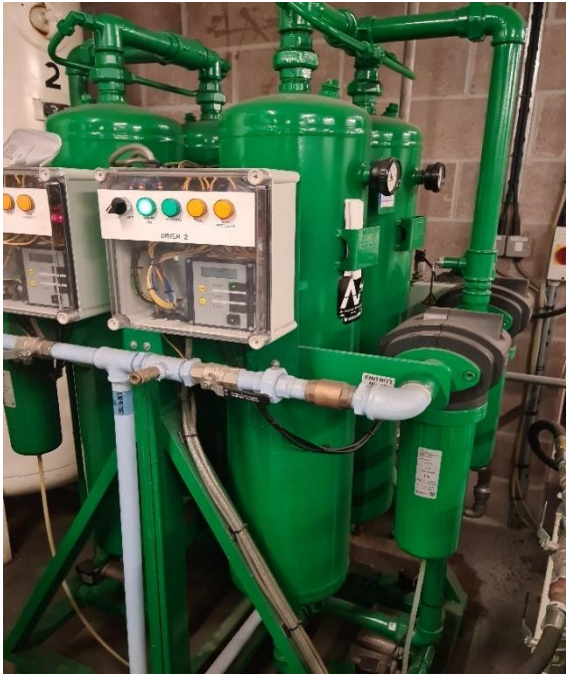
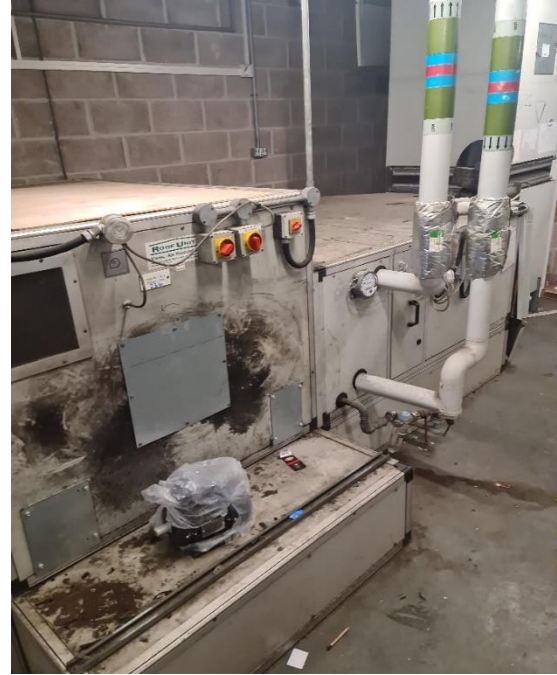
Below is the Anaesthetic gas scavenger, even though it looks in good condition is 20+ years old and parts are becoming obsolete as they ceased to be manufactured several years ago.

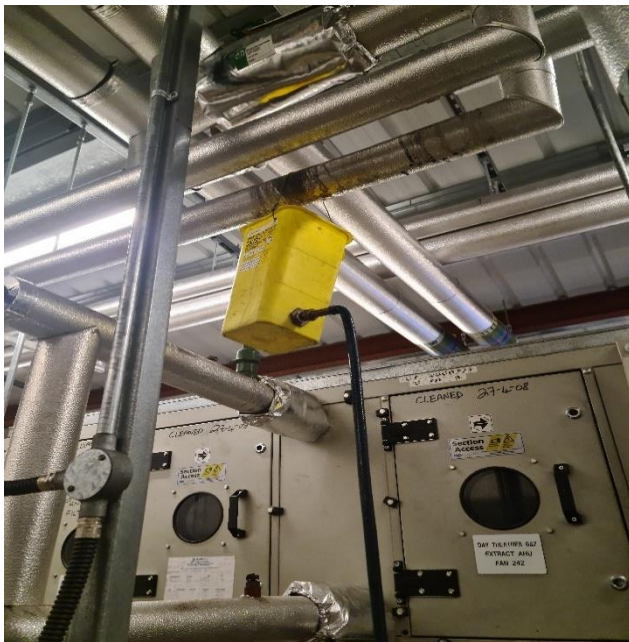
Below are photos of the energy centre at UHW, again as you can see the plant has had constant repairs and suffers with constant leaks. The boilers are 30 years old and have outdated controls and burners. The electrical systems in some cases date back 51 years.

This photo shows a work around that is currently in place to prevent a leaking pipe disrupting the plant below it. A sharps bin has been suspended from the leaking pipe and a drainage hose attached to the bottom to allow the water to run out and prevent overflow.

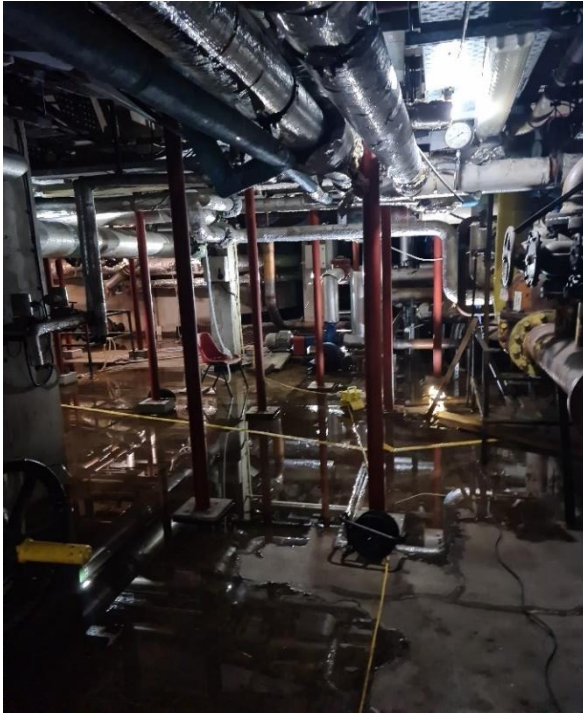
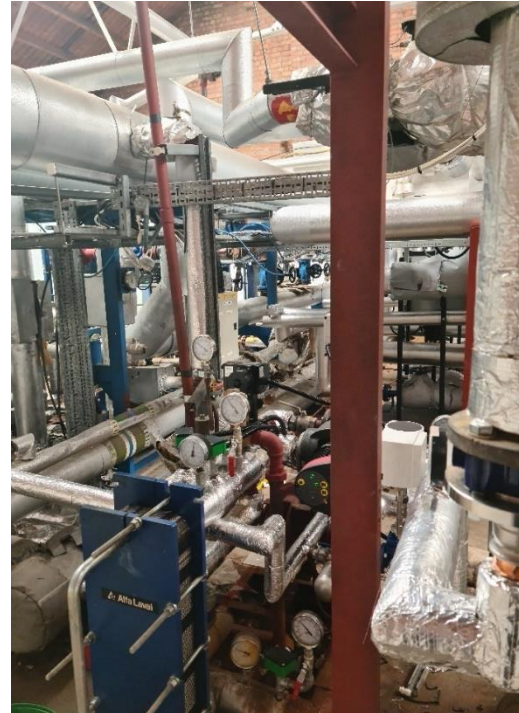
Below are examples of leaks within the basement of the energy centre and the props installed as the floor needed extra support due to additional equipment above.

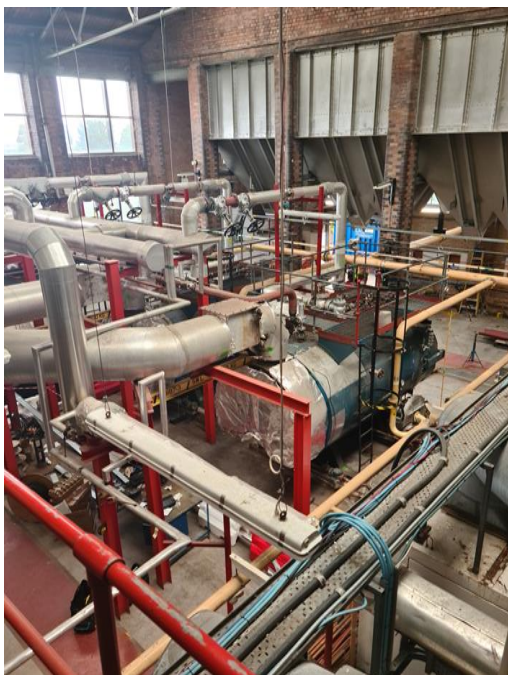
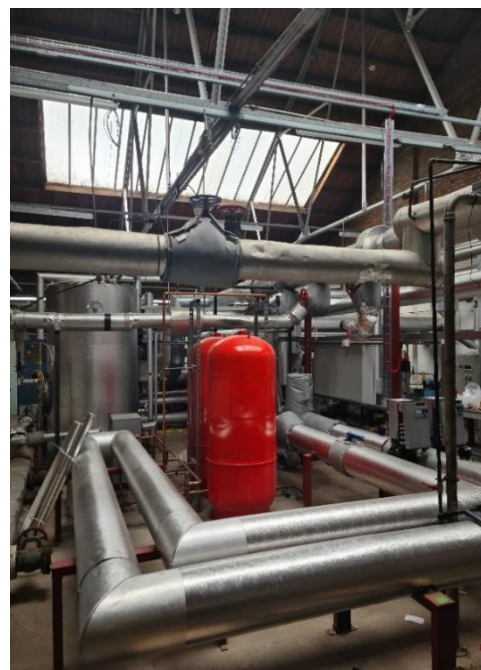
Below is the UHL energy centre, as you can see from the photo there has been major additions to the plant, this puts more demand on the aged infrastructure. The boilers are again 30+ years old with obsolete controls. The CHPs (combined Heat Power Plant) have reached the end of their life and have been shut down for the last 5 years.

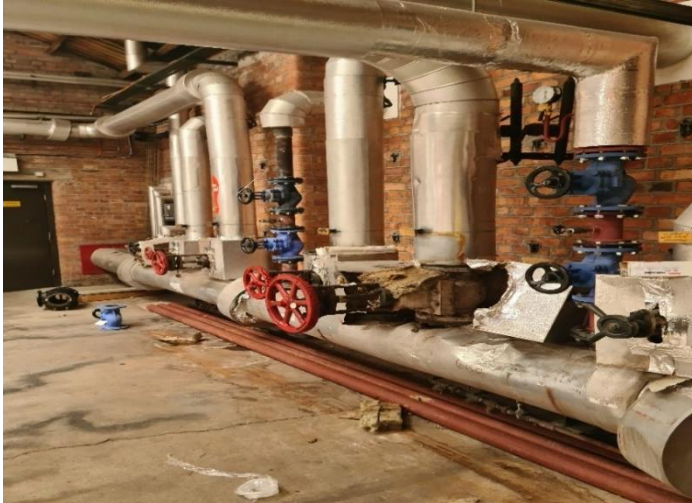
Below is the steam header. This is an example of where we are starting to put double valve isolation in as the current system is non-compliant. To complete the installation successfully with minimum disruption to patients, staff and services, several weeks of planning in collaboration with other services is essential as this work requires a site steam shutdown.

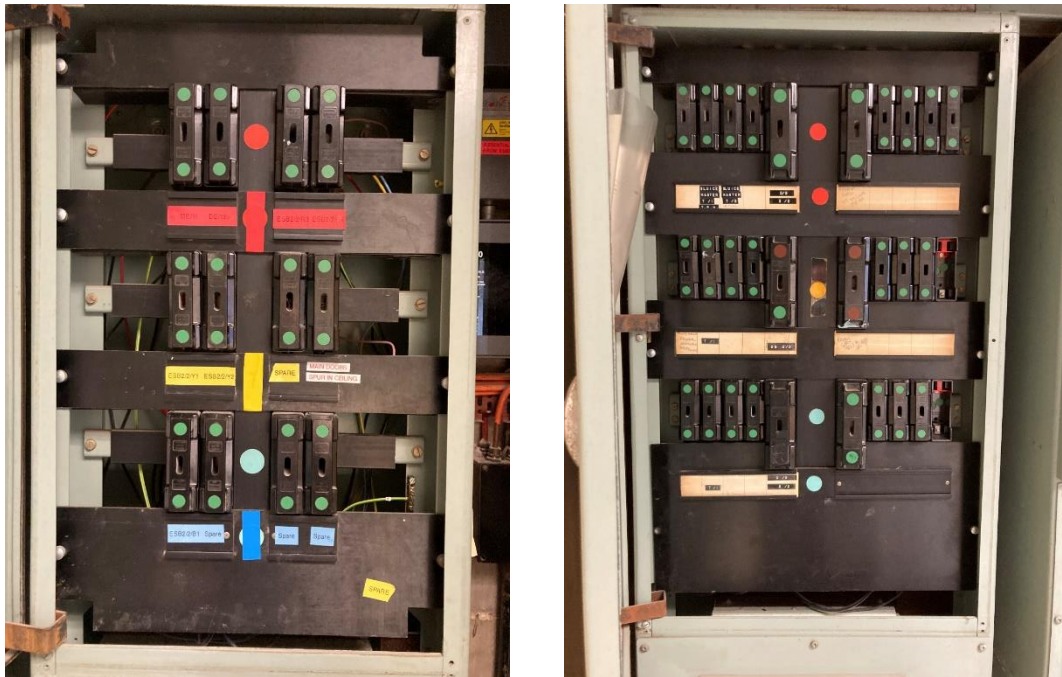
Typical Ward Riser essential and non-essential Distribution Board

The majority of the existing sub-main LV cabling is original AWA cabling from 1963. There are no separate circuit protective conductors installed with the cabling which was normal practice at that time, however this not compliant with current standards.

The main Riser Low Voltage Distribution Boards are all original Ottermill BS88 Fuse Boards, there is no IP protection within the Boards and due to the age there are exposed live parts.

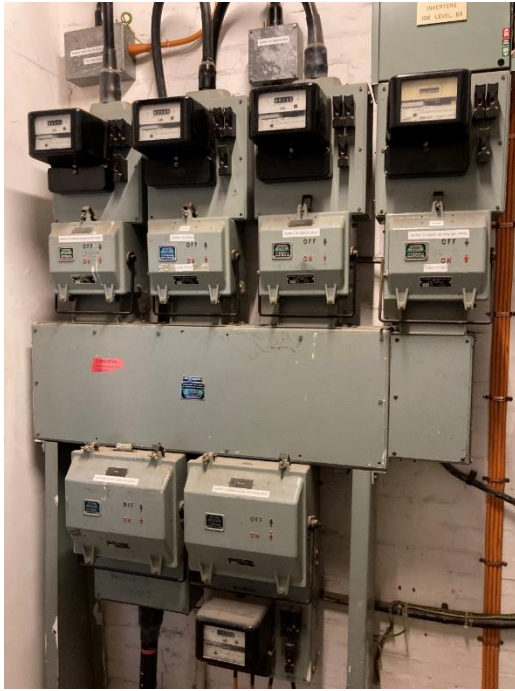
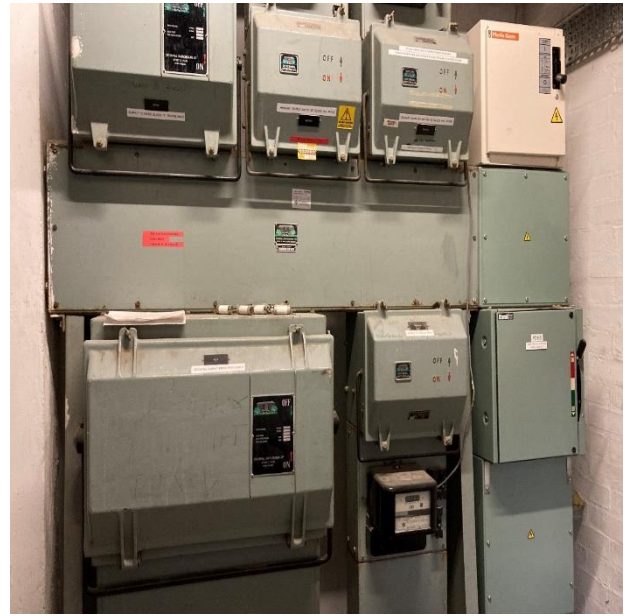
Typical LV main switch-room arrangement. Typical Ward Block riser main switchgear arrangement.

The manufacturer of the components in the photos above ceased their business 20+ years ago. Spare parts are limited at best and are a finite resource that will not be available in the future. Maintenance of these systems will then cease to be practical.
